CASCADE
INSPECTIONS
NORTHWEST

Windstrom Park HOA
PO. Box 910
Fairview OR. 97024

Stucco Privacy Wall Inspection

Inspection Date: June 29, 2015

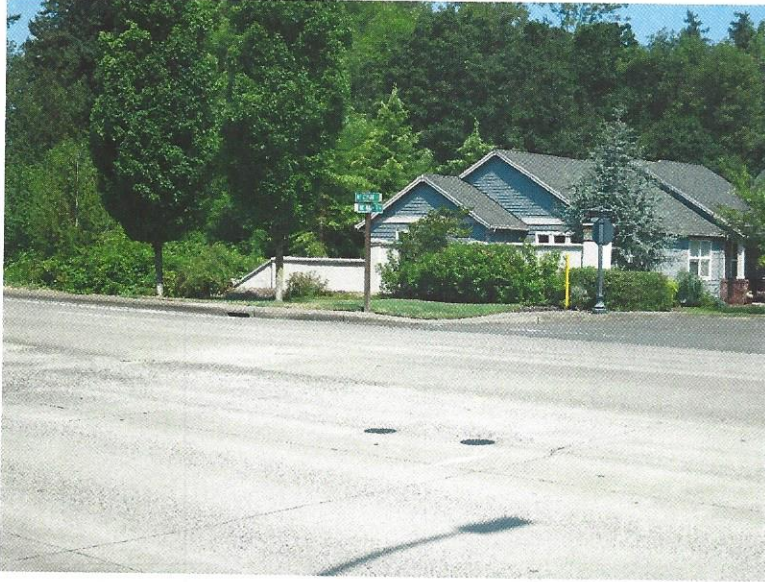
Figure 1 Westside of Wall Area

This is a photograph of the Western side of the wall area. The following photographs are closer views of this area.

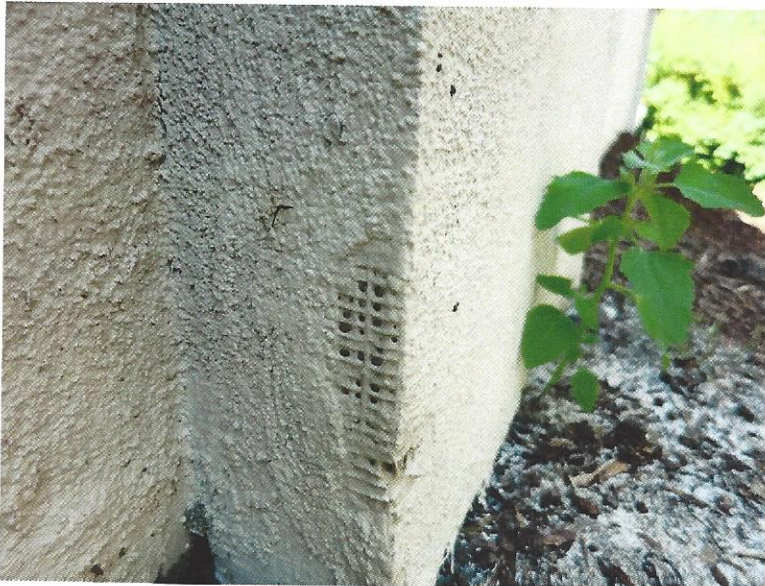
Figure 2 Westside of Wall Area

The inspector examined the foam EPS shapes that were attached to the wall system and found some areas where the fiberglass mesh was exposed.

Inspector recommends fully embedding all fiberglass mesh in a base coating of stucco compound.

This should be performed in all areas where any fiberglass mesh is exposed.

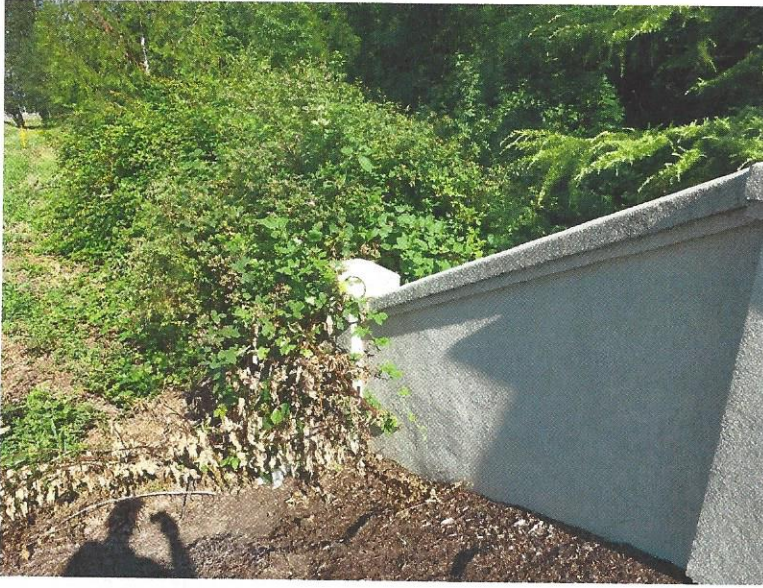
Figure 3 Westside of Wall Area

The inspector examined the Western termination end and found vegetation growing up against the side of the stucco wall system.

Any vegetation contact with the wall can cause damages in time.

This inspection firm recommends removing all vegetation from any contact with the wall system.

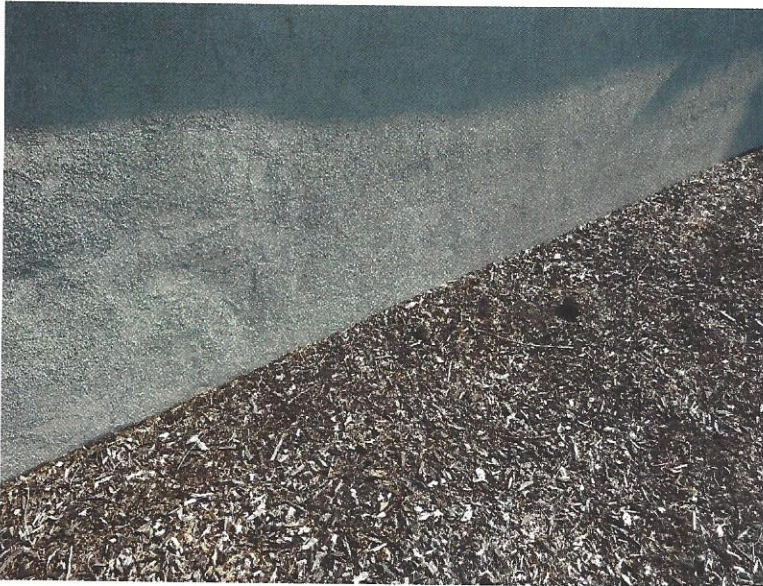
Figure 4 Westside of Wall Area

This is a photograph showing the base of the wall system.

The inspector found that there was soils backfilled up against the wall system in all areas.

The problem with this detail is that insects can enter inside the wall area undetected and can cause problems from nesting inside the stucco system.

Another problem is that soils will cause moisture to contact with the wall system and could cause damages to the metal lath system in time.

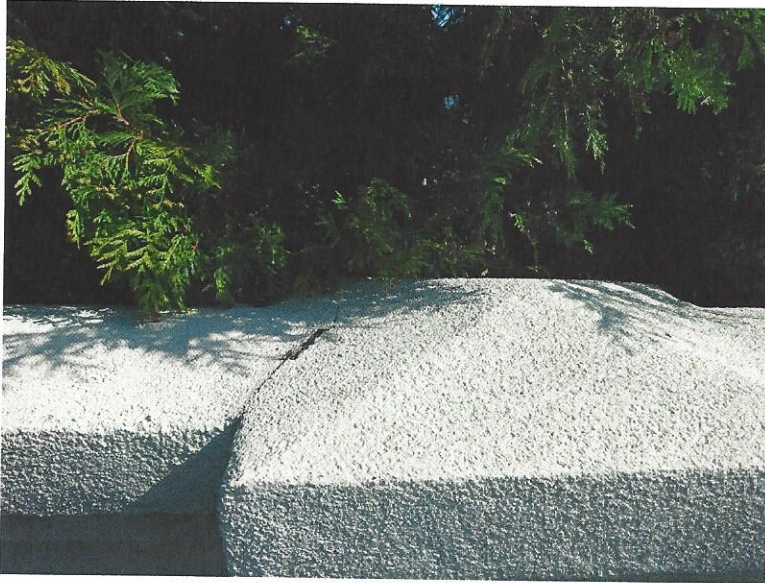
Figure 5 Westside of Wall Area

This is a photograph showing some cracking in the foam EPS top capping.

During the installation of the stucco system, the installer possibly did not lap the fiberglass mesh correctly which could cause this type of cracking.

This inspection firm recommends addressing any cracking in the top capping such as this by performing the following:

- The affected area should be ground down so the base coating is exposed.
- A fiberglass mesh should be bridged through the cracked area and embedded in a base coating of

stucco compound.

- A finished and colored top coating should be installed over the affected area.

Note: The inspector found that this wall system has been painted. It may be recommended to paint the repaired areas to match the existing.

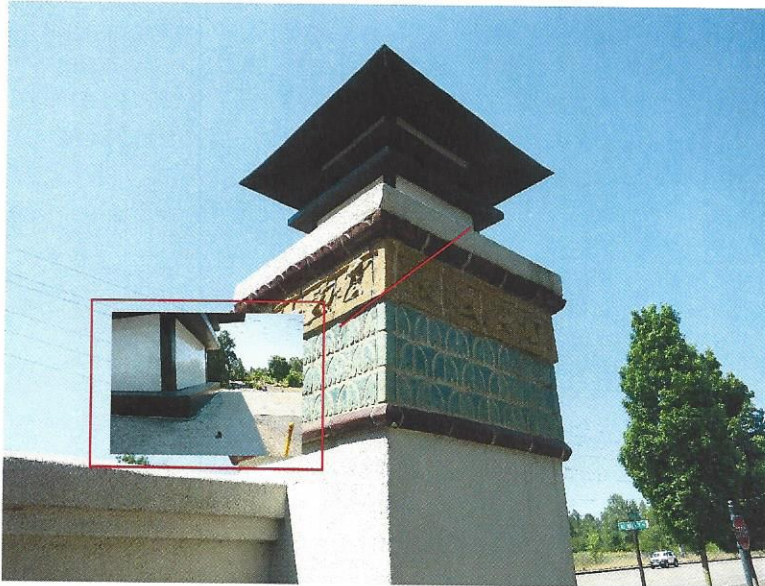
Figure 6 Eastside of Wall Area

This is a photograph that shows the aesthetic columns that were installed adjacent to the roadway that enters into the HOA property.

Manufacturer's installation specifications for the installation of the foam EPS shapes to a stucco system state that the shapes should have a 1 inch rise for every 2 inches of run.

The installer of the stucco system applied these shapes and left the top surface flat. Since these columns are constructed with masonry units, wood rot from moisture migration is not considered to be a factor. It is however recommended to apply an approved sealer to the top surface of the

foam EPS shapes to help prevent any type of moisture migration into the stucco system. It is also recommended to thoroughly caulk and seal between the foam EPS shape and any attached hardware such as lighting.

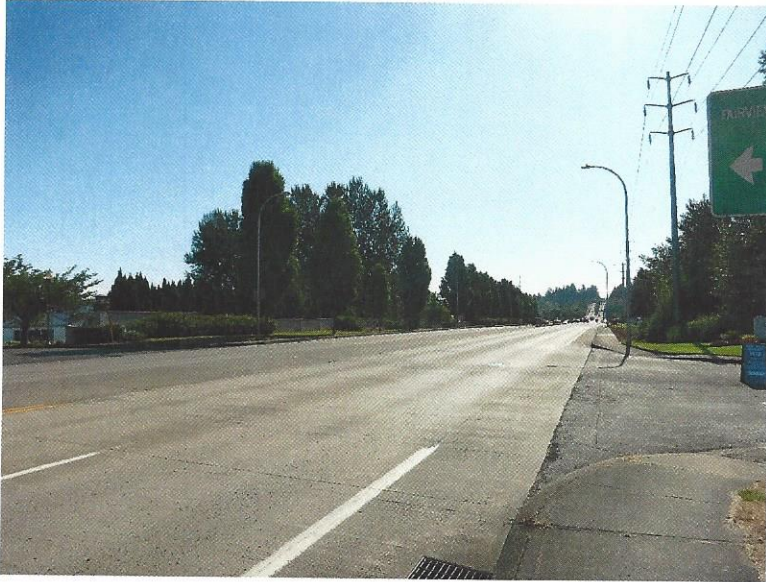
Figure 7 Eastside of Wall Area

This is a photograph showing the Eastern side of this wall area.

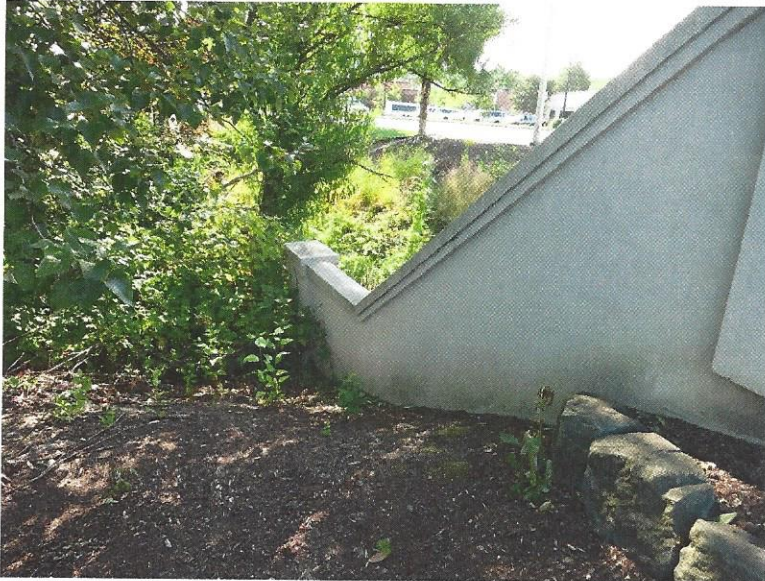
Figure 8 Eastside of Wall Area

This is a photograph showing the Eastern termination of this wall system.

As stated, all vegetation should be removed. Most damaging are blackberry bushes.

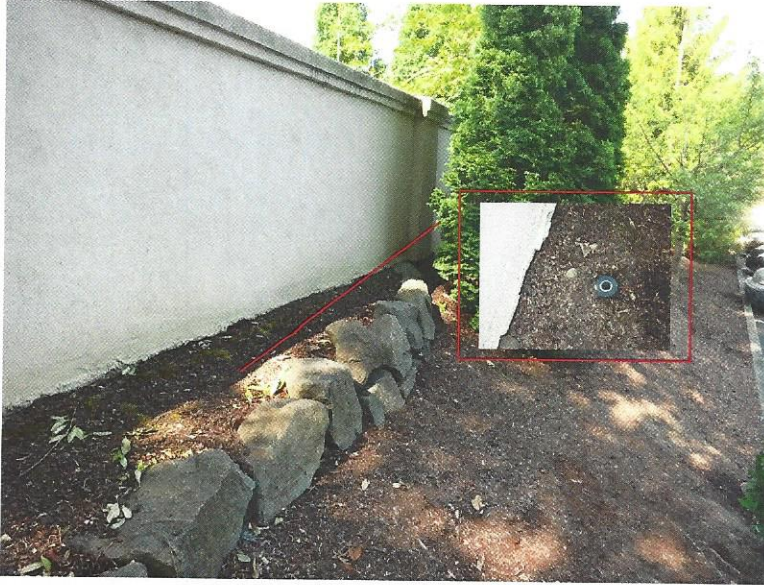
Figure 9 Eastside of Wall Area

This is a photograph showing the interior area of the wall system.

The inspector found irrigation heads for vegetation along the interior area of this wall system.

It is highly recommended that all irrigation be directed so that it is not emitting any moisture onto the wall system.

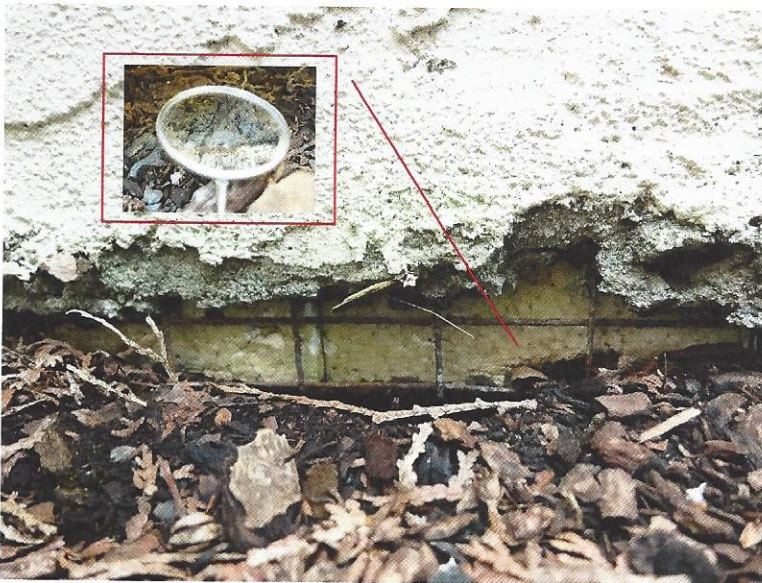
Figure 10 Eastside of Wall Area

This is a photograph showing the bottom termination edge of the wall system. As stated the wall system was constructed with foam EPS panels and it was finished with a stucco system.

One of the biggest concerns with this inspection firm, is that there could be damages to the wall system from insect movement and moisture.

The impact point for these problems is at the bottom termination edge of the wall system.

There are two options to help minimize any damages to the wall system and extend its life span to its maximum potential.

1. All irrigation heads should be redirected so they are not emitting water on the wall system. A pest-control agency should be retained to conduct regular treatments along the wall areas to help prevent any insect movement inside the foam EPS panels.
2. A more invasive approach would be to remove the soils from around the wall area and dig down approximately 1 foot underneath the wall system. The bottom termination edge of the wall system should be completely finished with a base coating of stucco compound where the wire lath is fully embedded. A landscaper's fabric would then be set down into the trench area and followed with the installation of a 1 1/2 inch round drainage rock.

This secondary option would help maximize the life expectancy of this wall system for decades.
